BIOREMEDIATION OF A HOME HEATING OIL, KEROSENE, SPILL
USING PROCATIVE BIOREMEDIATION PRODUCT S-200

NOVEMBER 2011

Louth County Council

Contractor: Comco Environmental
Paradise Place
William Street
Drogheda
Co. Louth

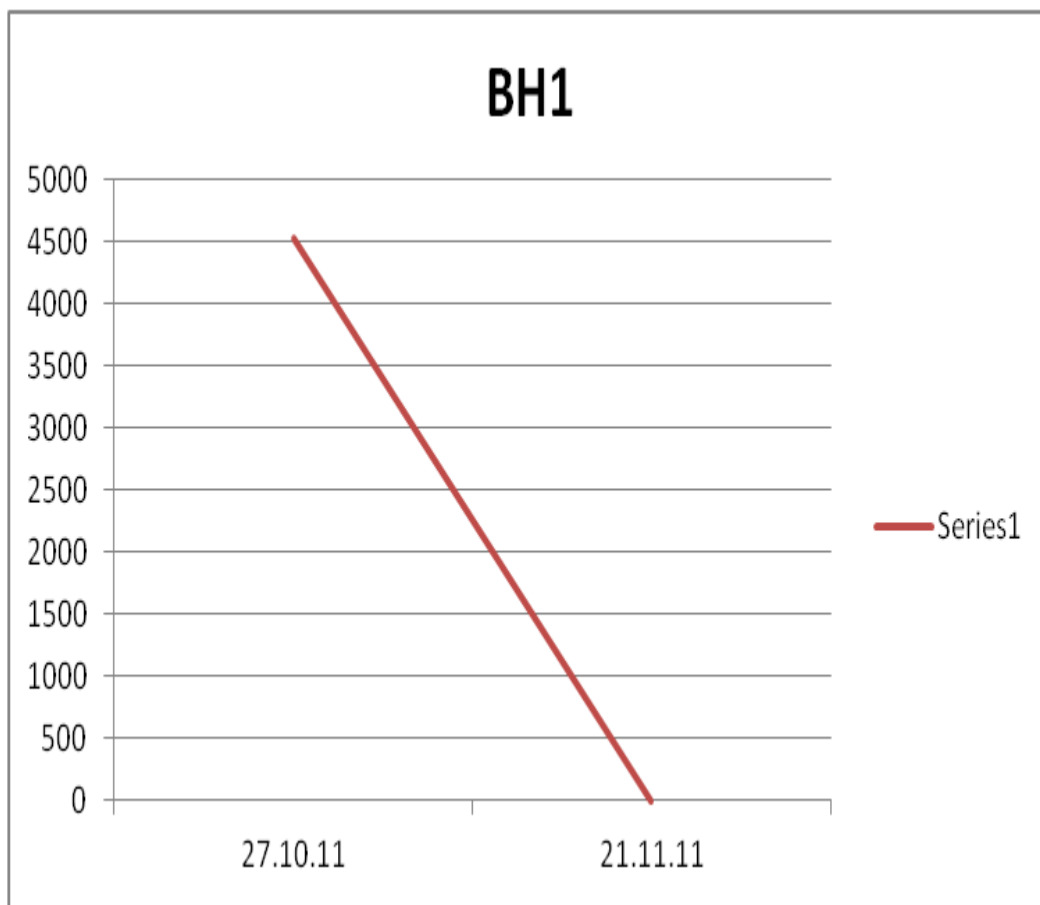
S – 200 mg/kg FUEL REMEDIATION RATE 99.99%

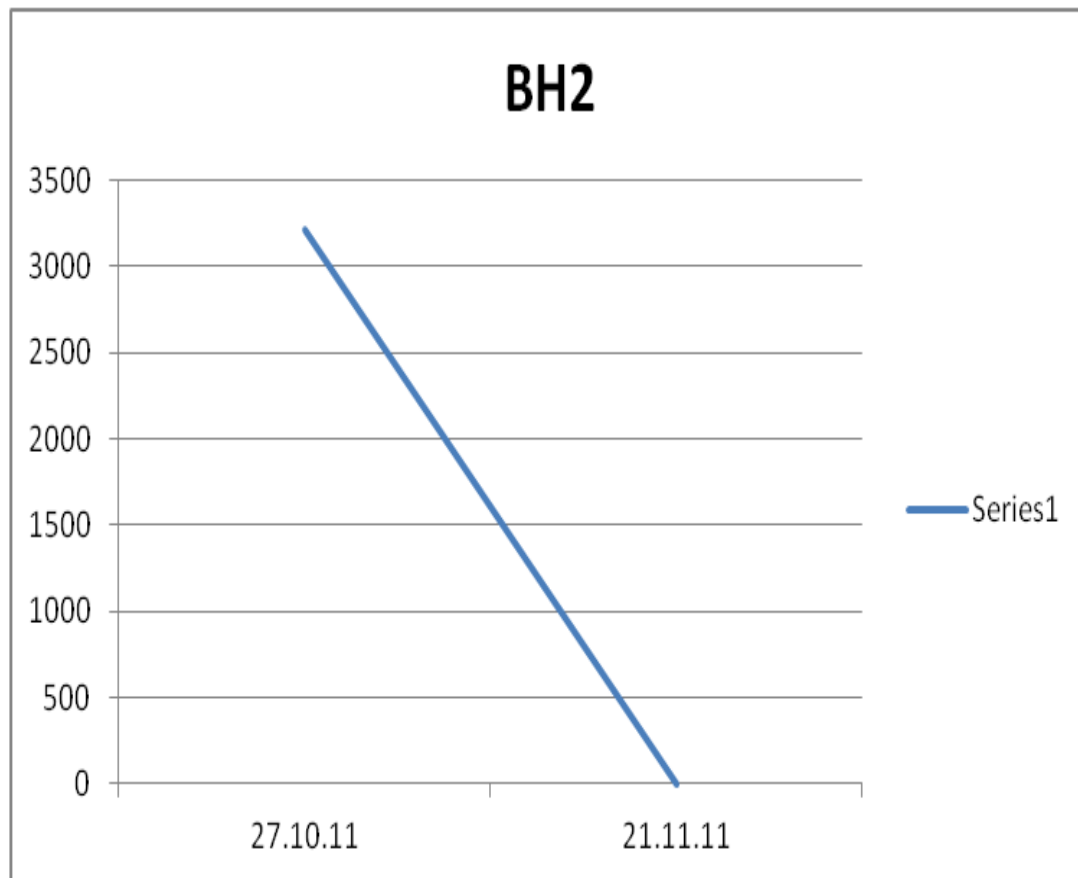
S – 200 mg/kg FUEL REMEDIATION RATE 99.99%

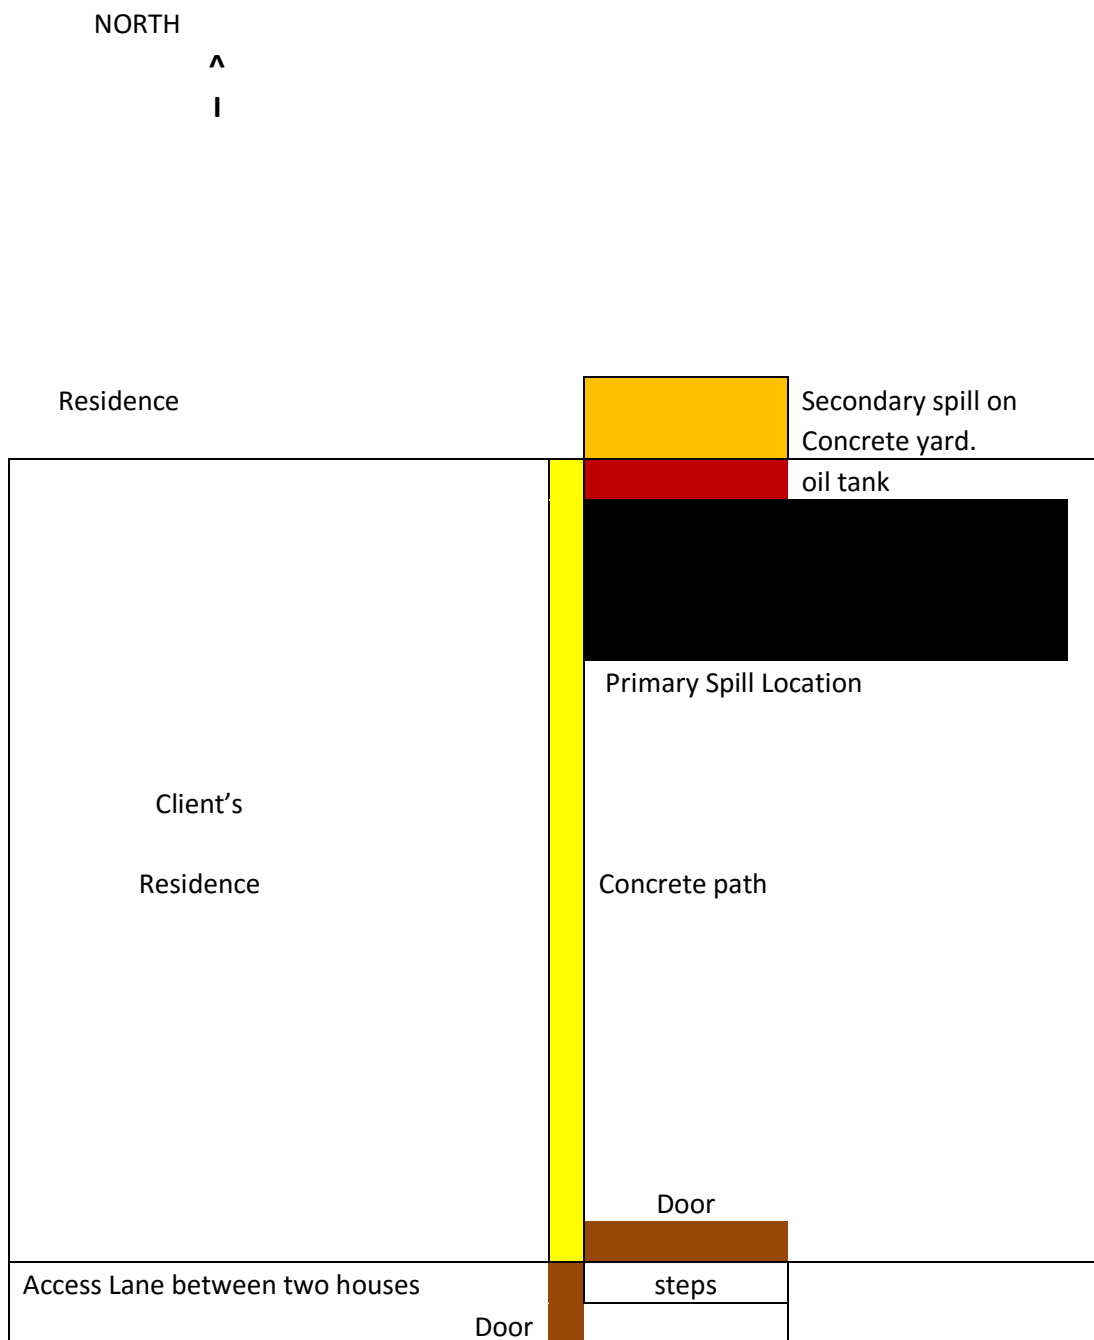
Site Map

The oil tank within the garden is located at the northern section of the garden with a concrete path and the main residence to the left (West) and a dividing single block wall to a neighbour's garden at the north. (Appendix 1)
